# Mixed-Signal Control Processor with ARM Cortex-M4/M0 and 16-Bit ADCs

## Silicon Anomaly List

## ADSP-CM411F/412F/413F/416F/417F/418F/419F

NR004483C

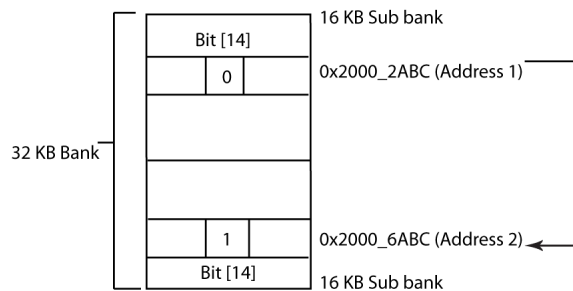
**19. 17000064 - Back-to-back Writes to Internal SRAM May Be Lost:****DESCRIPTION:**

When back-to-back writes are performed to the same 32 KB bank of the internal SRAM, the first write may be lost if address bit 14 is different (all other bits are the same) on the second write.

The figure shows an example where address bit 14 is different for two accesses.

The following workarounds utilize memory placement strategies, where two consecutive write addresses are not 16 KB apart.

For core-based accesses, the anomaly can occur on adjacent writes on the same bus between a local and global variable with addresses 16 KB apart and in the same bank.

In this case, the workaround is to use linker segments for code and variables to segregate them in a single 16 KB bank. If the total size is greater than 16 KB, place the variables in a separate 32 KB bank.

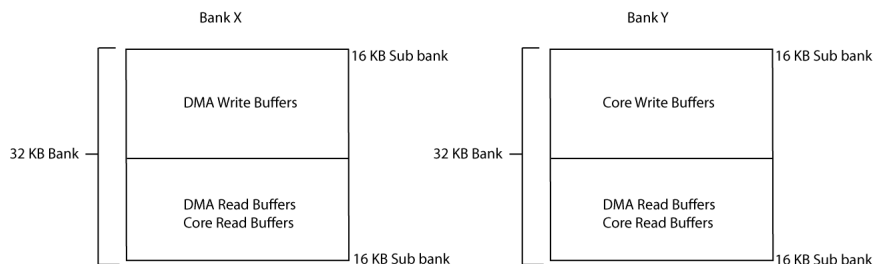
The figure shows the memory placement when DMA and Core write buffers are less than 16 KB.

1. If DMA requires less than 16 KB of data space or DMA requires between 16 KB and 32 KB of data space, but less than 16 KB for DMA writes, the workaround is to place the segregated write buffers either at the top or bottom half of the 32 KB bank. Ensure that the writable DMA data regions and read-only DMA data regions are in different half banks. Core-writable variables may be placed in the other half of the 32 KB bank that contains read-only DMA regions.

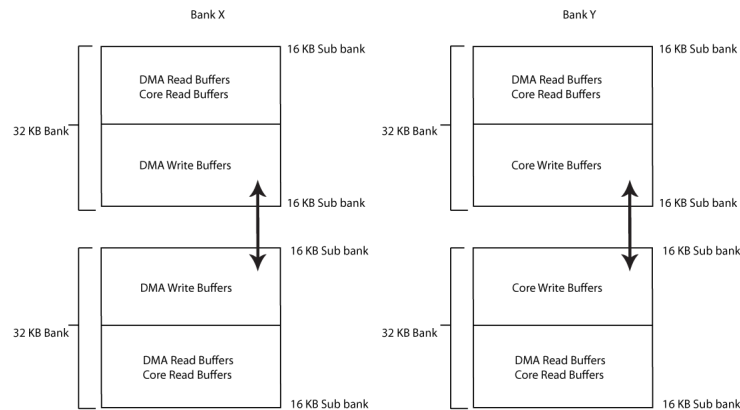
The figure shows the memory placement when DMA write buffers are between 16 KB and 32 KB.

2. If DMA requires more than 16 KB but less than 32 KB for writes, and DMA writes are a single linear stream, the workaround is to place the write data buffer in a single bank that has data in both halves of the bank. This issue does not exist in case of a linear addressed DMA. If DMA writes are not sequential and ordered and the DMA buffer requires more than 16 KB, the region must start from the higher half of the bank and continue into the lower half of the next bank. Core-writable variables may be placed in the other half of the 32 KB bank that contains read-only DMA regions.
