## NCL30088 and NCL30085 Safety Test Considerations

### APPLICATION NOTE

# AND9204/D

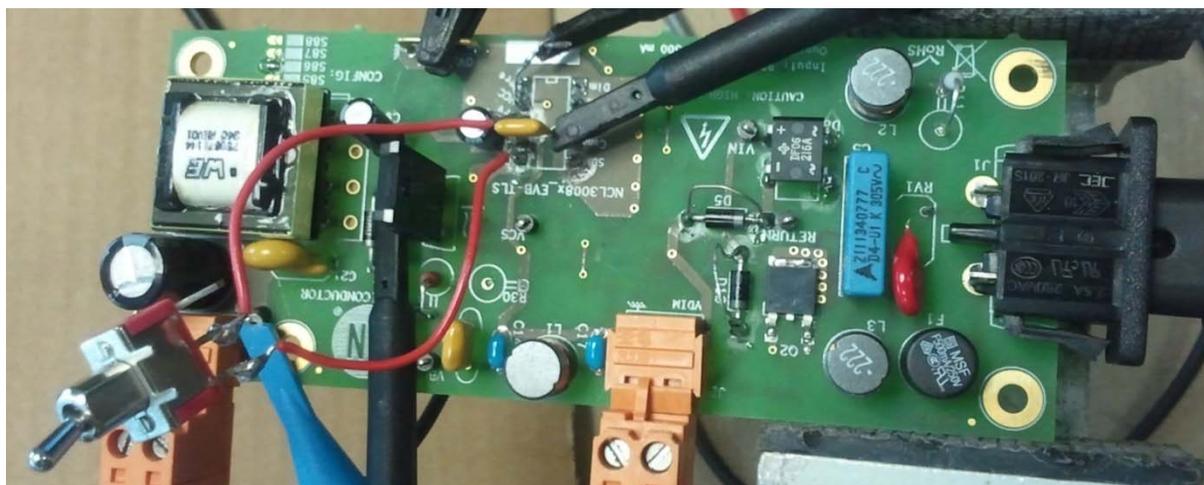
Figure 2. Shorts are Made by Means of a Manual Switch

SHORT faults were made by means of a manual switch so that SHORT conditions could be applied before and during operation. Pin floating conditions were created by inserting a socket between the board and the socket the circuit was soldered to. The appropriate pin of the intermediate socket

was removed to test the floating fault under interest. The manual switch gave the possibility to reconnect the NCL30088 pin. Tests were made at 25°C ambient temperature.
